Manhole Inspection Summary

Manhole # S41E__069MH

Location Address: **1400 lombard st**

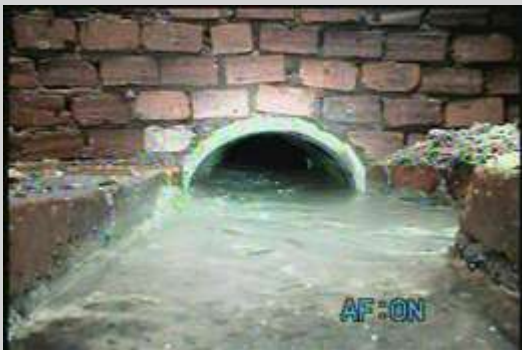
12 O'Clock Outflow

8 in. Circular Gravity Sewer
Pipe Out @ 12 O'Clock

Pipe Material: **Clay** ☐ Pipe Lined

Invert Depth: **13.07** (ft.) Flow Characteristics: **Fast**

Deposits: ☒ None ☐ Mud ☐ Sludge ☐ **Debris** ☐ Grease

Infiltration: **None** Pipe Seal Cond: **Unknown**

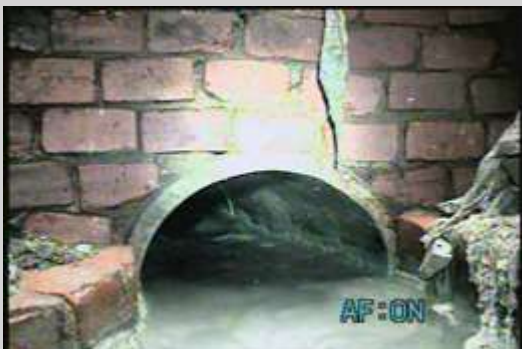
3 O'Clock Inflow

8 in. Circular Gravity Sewer
Pipe In @ 3 O'Clock

Pipe Material: **Clay** ☐ Pipe Lined

Infiltration: **None** Pipe Seal Cond: **Unknown**
